Furnishings Plan

List of Recommended Furnishings with Room Plans

34 Conductor's/Waiting Room Room 101

Telegraph and Ticket Office Room 103

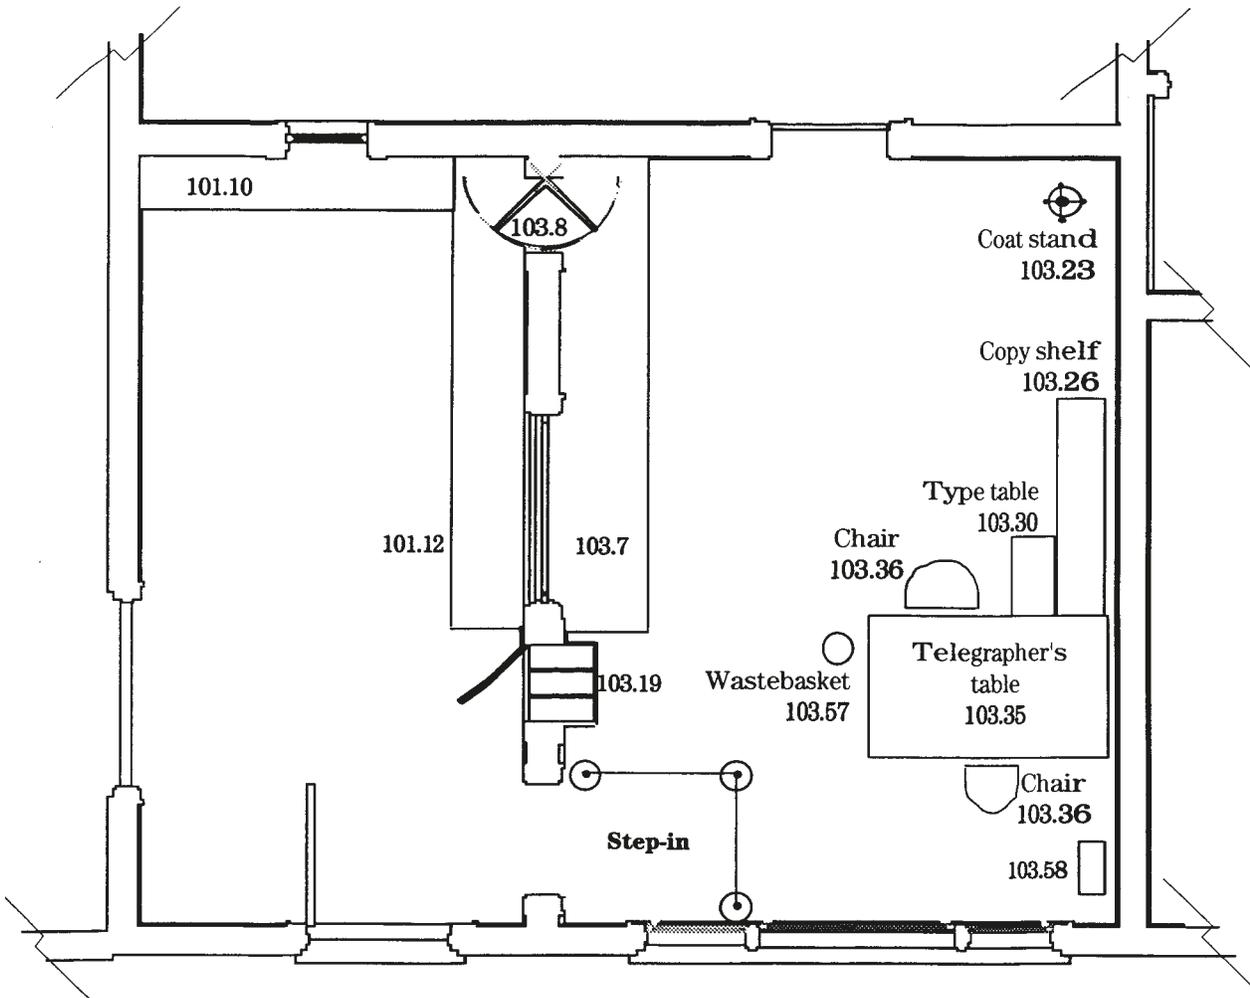
Room 101
Conductors/Waiting

Room 103
Ticket/Telegram

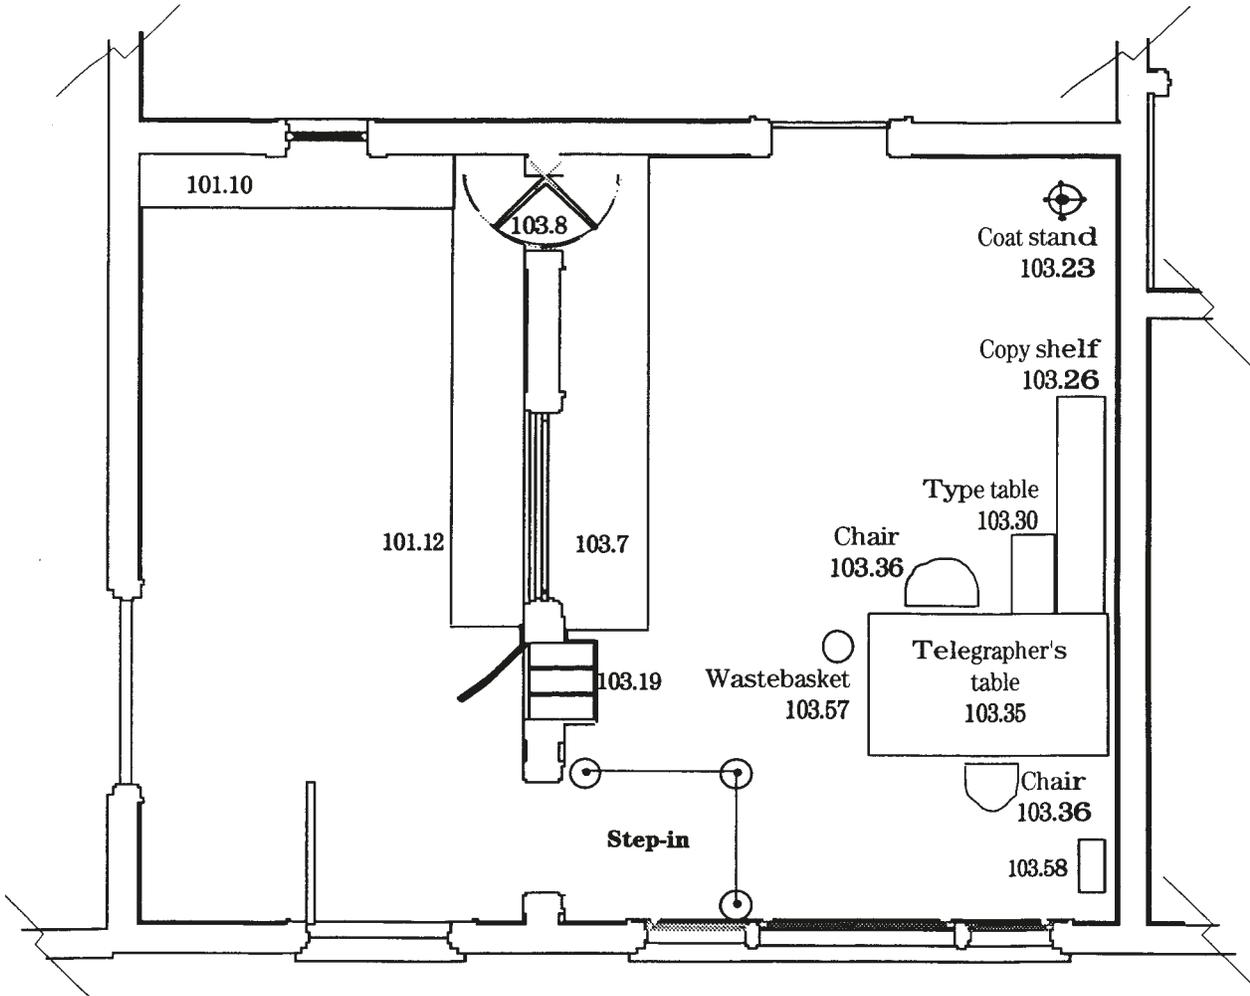
Room 101
Conductors/Waiting

Room 103
Ticket/Telegram
